## Kings Bridge bearings – TRAFIKVÄRKET – Fagersta, SWEDEN

The purpose for this project was to do a test for **Trafikverket (The Swedish Road Authorities)** to show them the performance of **ZINGA** for rehabilitation of different complicated structures. In this case 4 bridge bearings of the **Kungsbron (Kings Bridge)** in Fagersta, a municipality in the North of the **STORA ASPEN Lake**.

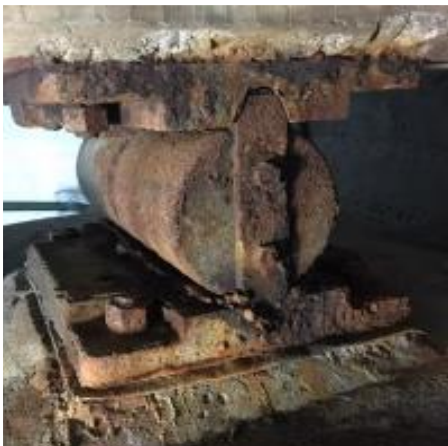
Before cleaning  
and blasting

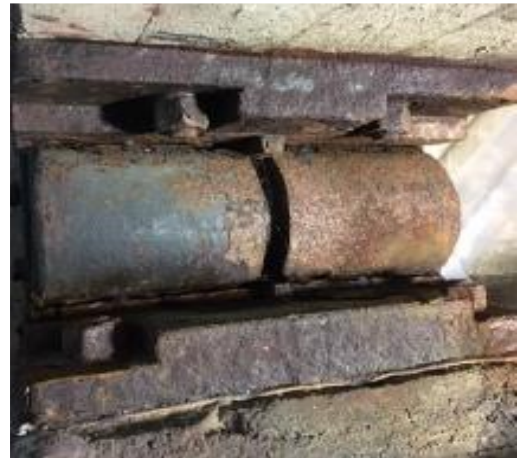
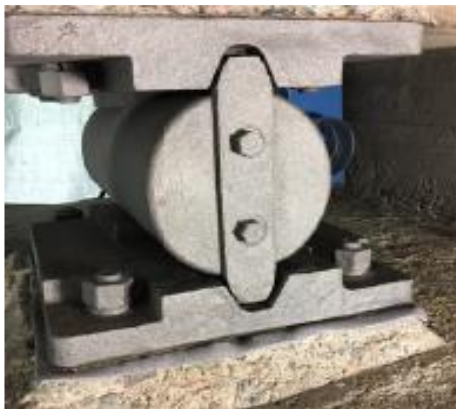
After cleaning  
and blasting

Surface preparation:  
High pressure cleaning 180 bar  
Gritblasting to degree SA 2.5  
ZINGA 3 x 60 µm DFT by brush

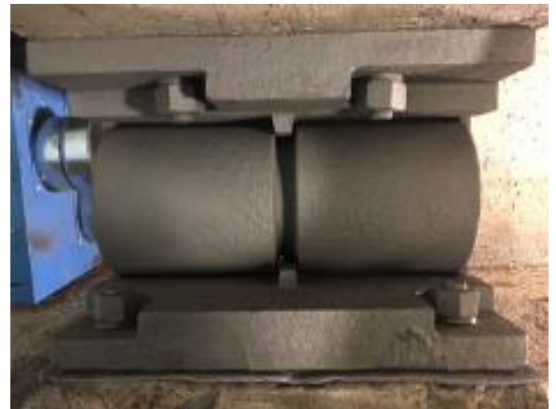
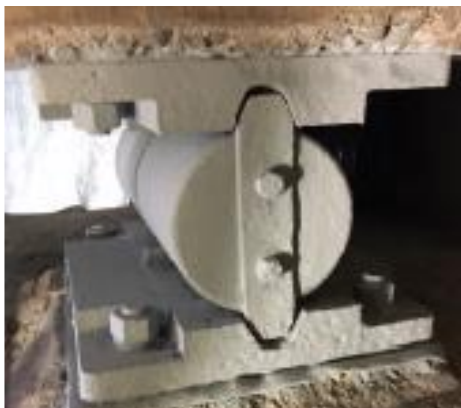
After  
application  
of **ZINGA**  
180 µm DFT

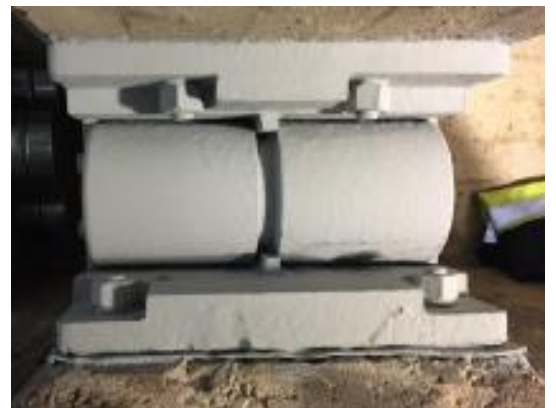
After application of **ZINGA**.  
This picture shows the shiny metallic zinc  
after a coin rub test was performed.
