## TARWIN RIVER BRIDGE- AUSTRALIA

This bridge over the Lower Tarwin Estuary (brackish water) in Victoria, Australia that was previously protected with an inorganic zinc system (IOZ) and this IOZ has been recharged using ZINGA during November 2007.

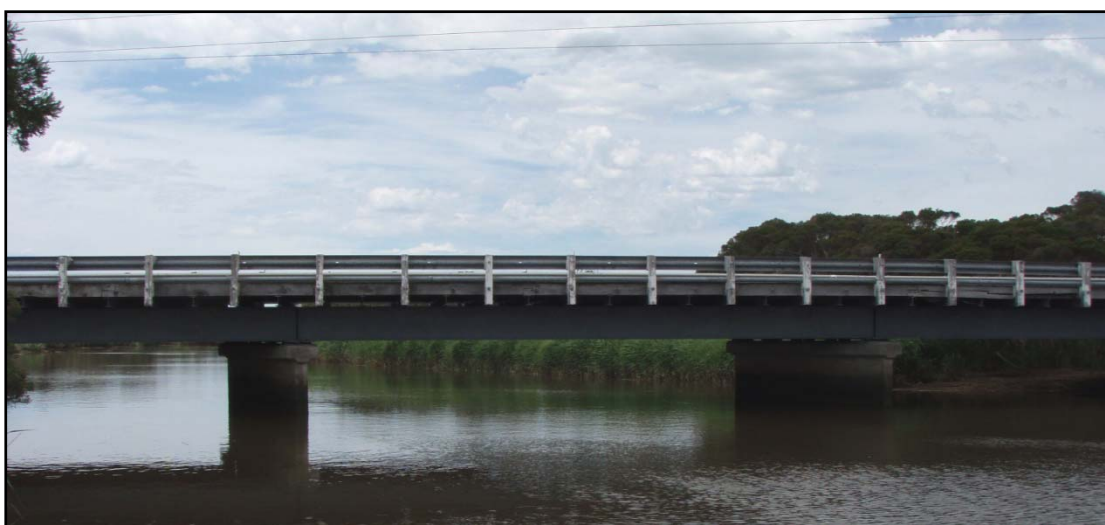
What is special about this bridge is that ZINGA has been used to recharge an IOZ system. In the past an old IOZ had to be removed completely to the bare metal, while with ZINGA an abrasive blast suffices as a surface preparation, allowing the remaining IOZ to keep doing its job, again saving money for the owner.

**System:**

Surface preparation:

HP washing

Full blasting &amp; Sweep blasting

ZINGA 1 x 60 µm touch-up

ZINGA 1 x 60 µm full coat

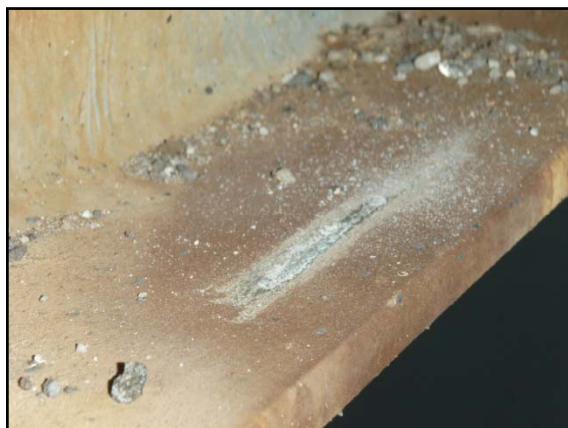
On the picture below you see why an abrasive blast was necessary to provide a sufficient surface preparation before applying ZINGA.

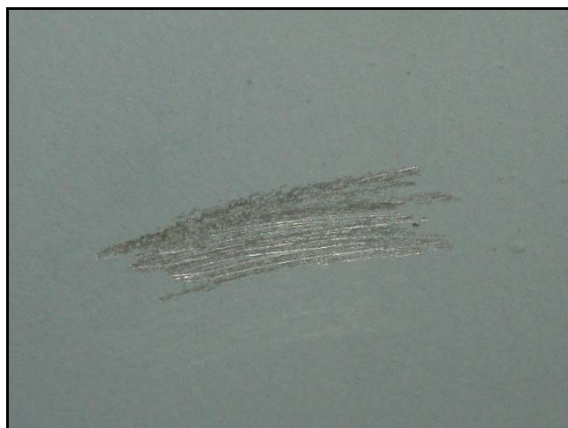
On the picture below you can see that the adhesion of ZINGA on this IOZ is excellent. What you see is the zinc in ZINGA.
