# NATO – NATO PUMP STATIONS - BELGIUM

In May 2003, 17 years after the application, the piping was officially inspected by SGS Axa-Med.

Type of intervention	<b>INSPECTION / SURVEY</b>
Object	Piping of the NATO pump station
Location	NAZARETH
Date inspection	13/05/2003
Time inspection	15:00

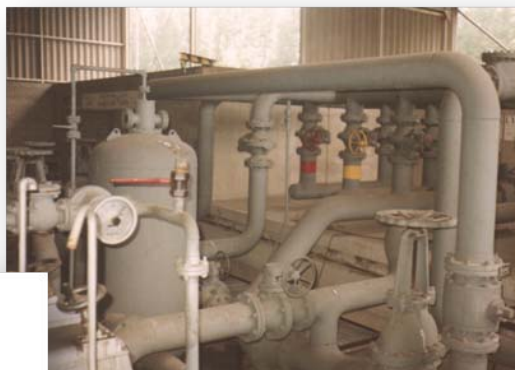
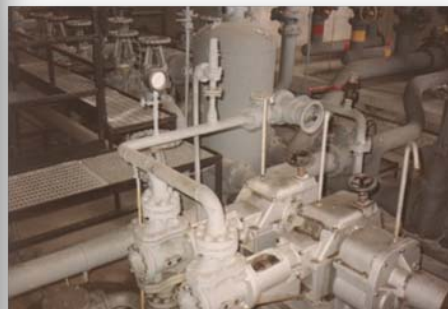
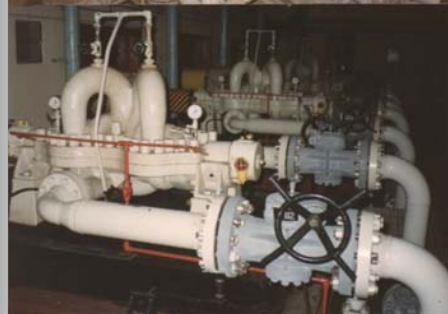
**System:**  
ZINGA      2 x 60 µm

It was still in a very good condition and showed no sign of corrosion.

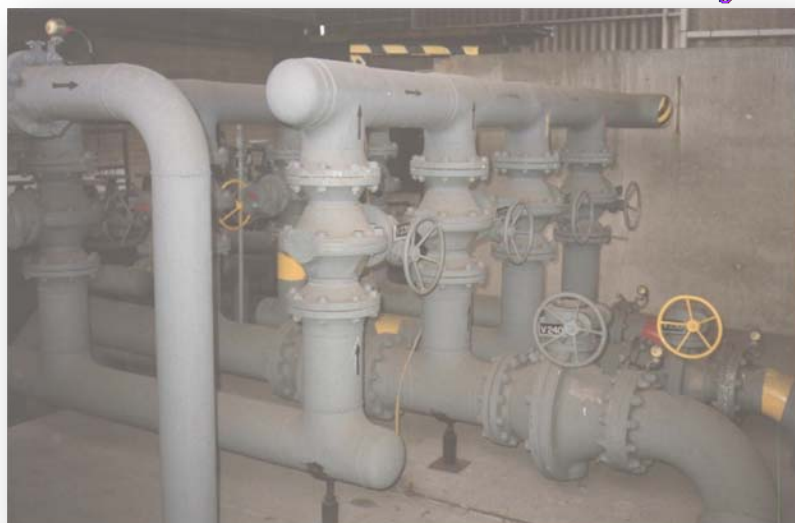
ELCOMETER BATCH NR./OBJECT ↓	Layer	Mean DFT (µm)	% < Abs.Min	% > Min	OK/NOK
F1 NATO EKE 1	2/2	199	0	100	OK
F2 NATO EKE 2	2/2	174	0	100	OK
F3 NATO EKE 3	2/2	220	0	100	OK

The film is closed and has a light grey look.  
No corrosion was seen on the piping. Only small rust breakthrough was stated on secondary equipment delivered with another primer and over coated with Zinga in order to have a uniform colour.  
Further, no film deterioration was found.
